### Habitat and Terrain Survey

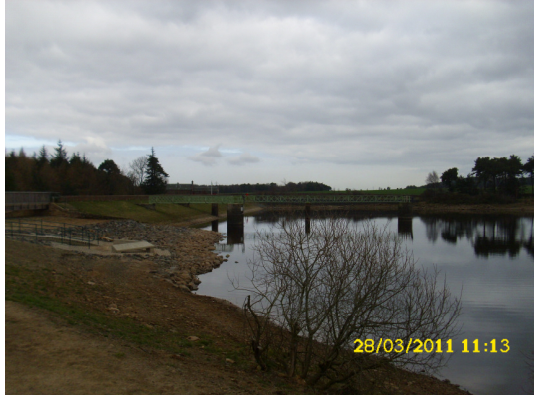
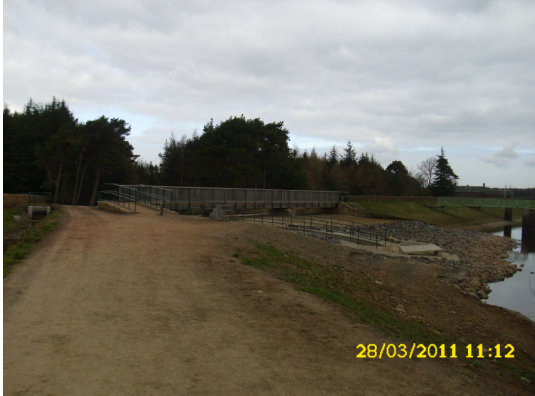
Location Number:	Grid Reference (if available)
1	
<b>Observations:</b>	
Harlaw reservoir, the two intake towers and footbridge over spillway	
<b>A: Left tower to be used as hydro intake</b>	<b>B. Spillway and footbridge</b>

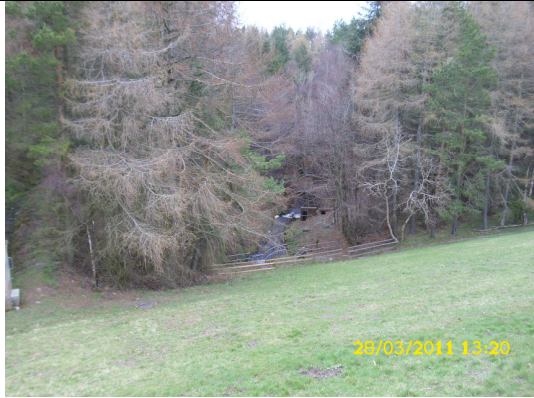
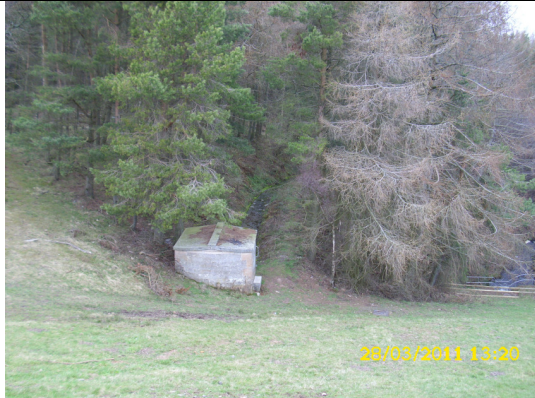
Location Number:	Grid Reference (if available)
2	
<b>Observations:</b>	
Overview from top of dam looking down at Bavelaw burn. See dense forestry on each side of the burn	
<b>A: Lower outflow. Hut shows turbine house location</b>	<b>B: Upper outflow</b>

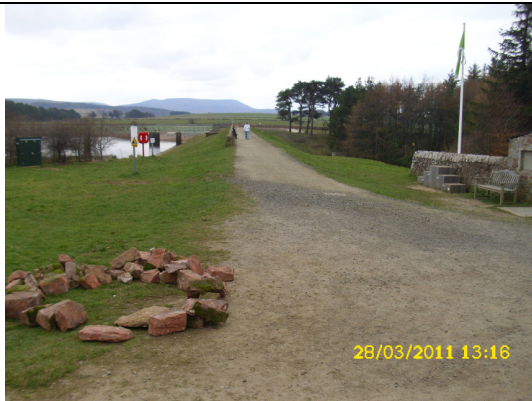
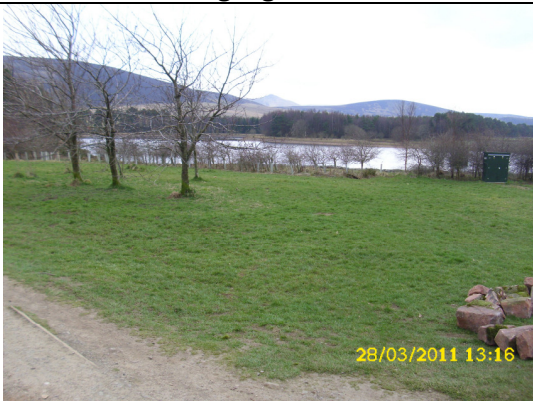
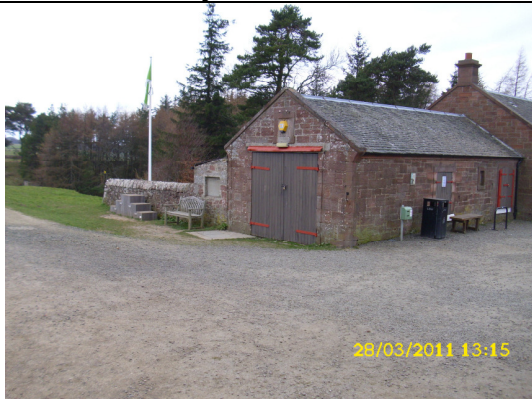
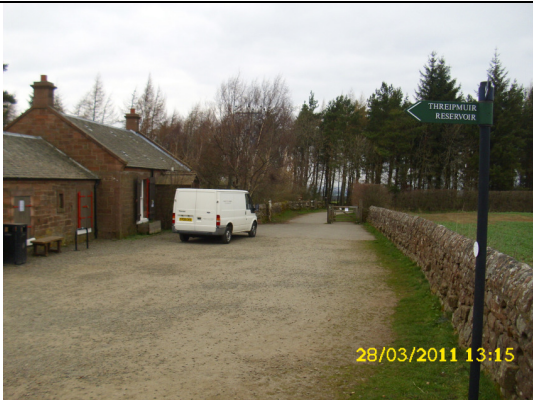
<b>Location Number:</b>	<b>Grid Reference (if available)</b>
3	
<b>Observations:</b>	
Harlaw Reservoir and dam and access.	
<b>A: Context</b>	<b>B. Potential staging area</b>

<b>C. Access to turbine house via track to the left of dyke</b>	<b>D. Access road to Harlaw</b>

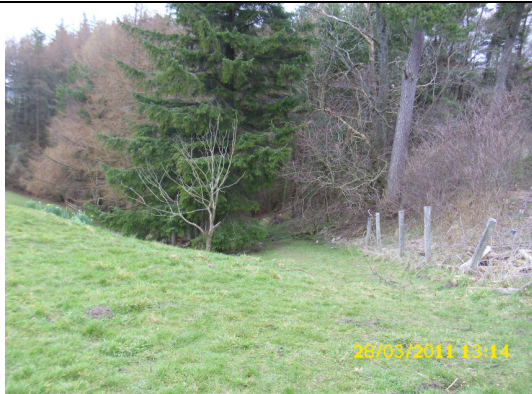
<b>Location Number:</b>	<b>Grid Reference (if available)</b>
4	
<b>Observations:</b>	
Existing track to turbine house location cuts through the trees. Upgrading and the removal of some tree may be necessary.	
<b>A: Context</b>

Around the turbine house the terrain is more open. It was the historic site of hydraulic ram and the existing buildings here are proposed to be demolished and replaced with the turbine house. An existing access path which passes through the woodland from the Ranger Station will require upgrading before construction vehicles can access the site.

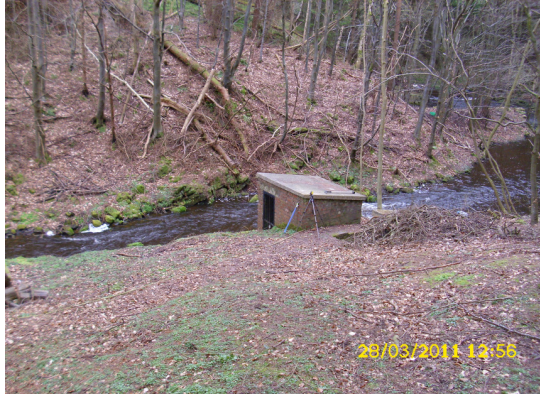
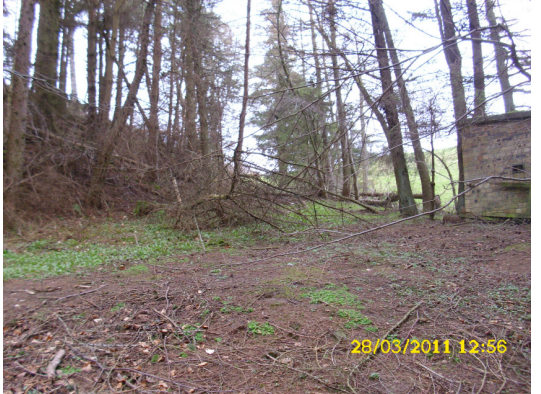
<b>Location Number:</b>	<b>Grid Reference (if available)</b>
5	
<b>Observations:</b>	
Turbine house to sit on site of existing hut in clearing in the forest.	
<b>A: Context</b>	<b>B. Looking back up at access track</b>

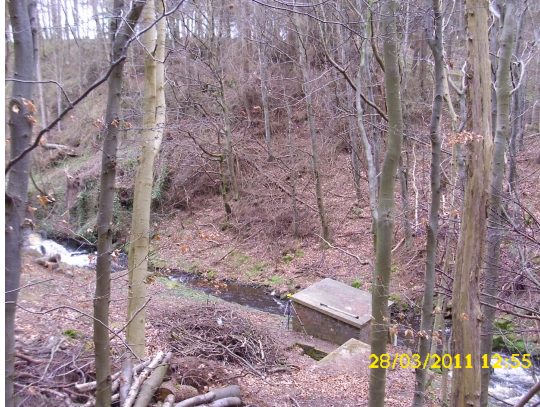
<b>Location Number:</b>	<b>Grid Reference (if available)</b>
6	
<b>Observations:</b>	
Pipe to come down the steep bank and forestry on the far side of the burn. Also see turbine house location	
<b>A: Context</b>

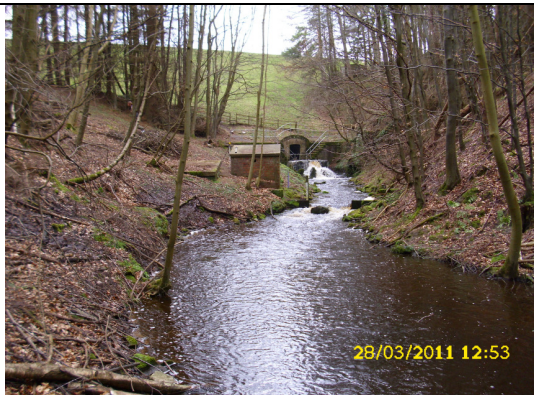
Location Number:	Grid Reference (if available)
7	
<b>Observations:</b>	
Burn gorge. Turbine house to be on the right, pipe coming from the left and crossing river via a pipe bridge.	
<b>A: Context</b>

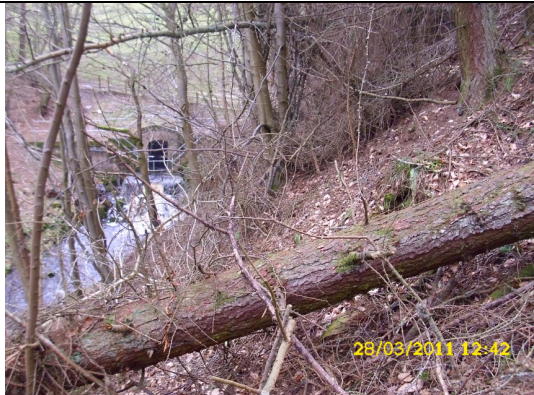
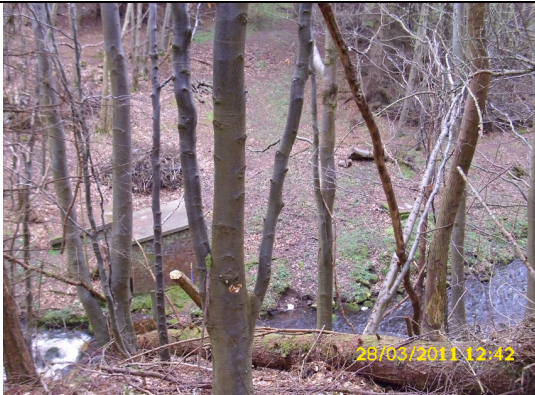
Location Number:	Grid Reference (if available)
8	
<b>Observations:</b>	
Steep terrain from the river crossing up to the spillway (see 7 below) Dense forestry, fallen trees, and boulder/bedrock	
<b>A: Context</b>	<b>B. Looking at potential pipe bridge to turbine house</b>

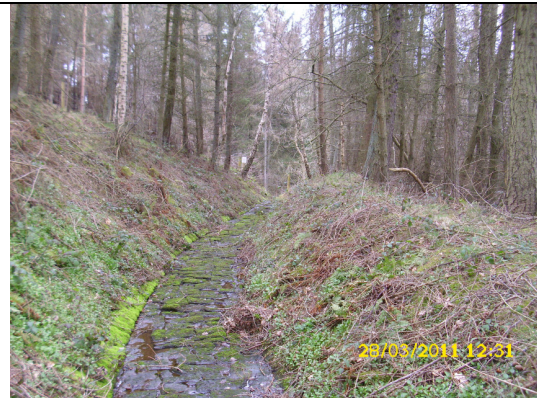
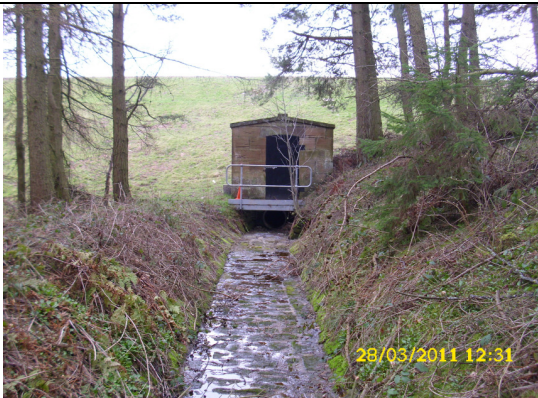
<b>Location Number:</b>	<b>Grid Reference (if available)</b>
9	
<b>Observations:</b>	
The existing outflow channel from the reservoir cutting through the forestry	
<b>A: Downstream</b>	<b>B: Upstream to reservoir outflow and valve house</b>

The pipe will be laid along the existing outflow channel from the second intake on Harlaw Reservoir. This channel is constructed out of stone so bedding material will need to be imported. Upon exiting the channel the terrain is generally steep with the potential for bedrock below the topsoil. The area is also covered with medium density conifer woodland with significant windfall. Access to this side of the system/dam, for vehicles over 3 tonnes, will be made via Threipmuir and down the existing spillway

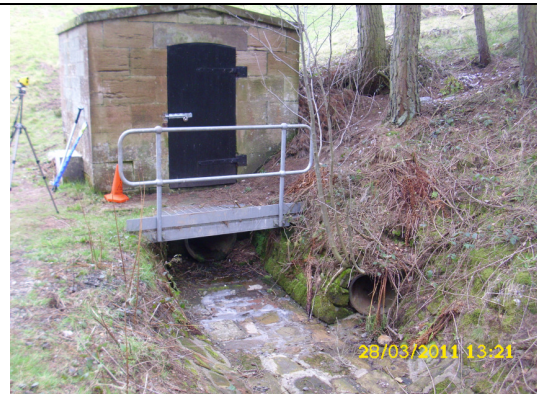
<b>Location Number:</b>	<b>Grid Reference (if available)</b>
10	
<b>Observations:</b>	
Existing outflow from lower intake and Scottish Water scour outflow.	
<b>A: Context</b>
